Report No. VTRC 05-R25	Report Date March 2005	No. Pages 27	Type Report: Final Period Covered: 05-01-04 to 02-28-05	Project No.: VTRC 73232 Contract No.
Title: Effectiveness of Sacrificial Anodes in High-Resistivity Shotcrete Repairs				Key Words: Cathodic Protection, Concrete, Corrosion, Halo Effect, Sacrificial Anode, Shotcrete, Steel
Authors: Michael C. Brown and Stephen R. Sharp				
Performing Organization Name and Address: Virginia Transportation Research Council 530 Edgemont Road Charlottesville, VA 22903				
Sponsoring Agencies' Name and Address Virginia Department of Transportation 1401 E. Broad Street Richmond, VA 23219				
Supplementary Notes				
<p>Abstract</p> <p>This study investigated the use of discrete sacrificial anodes to improve the durability and extend the life of a shotcrete patch repair in a column. Three columns were used in the investigation. In two columns, anodes were placed around the perimeter of the repair area. In a third column, used as a control, anodes were not placed inside the repair area. Shotcrete was then placed in the repair areas of all three columns.</p> <p>The study found that the current density level needed to improve the resistance of th

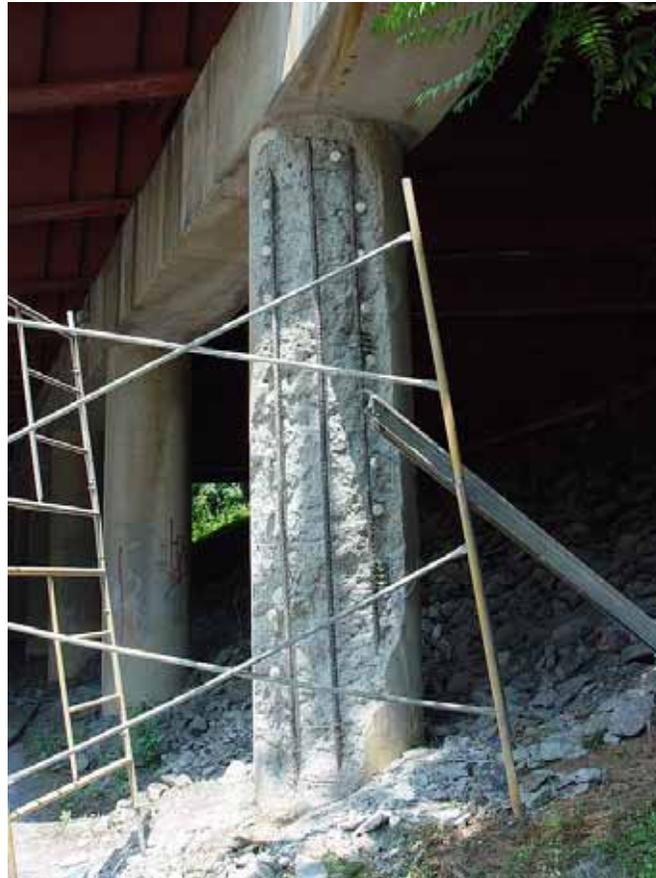
Figure 3. Placement of Anodes in Shotcrete Repair Areas

greater than 24 in on center. Since potential concerns included the high resistivity of the shotcrete and uncertainties about the force to which each anode would be subjected while the shotcrete was being applied, the investigators decided that the spacing would be dictated by locations where the horizontal steel spiral reinforcement crossed the primary longitudinal reinforcement in the columns. This would provide excellent continuity between the horizontal and vertical steel components while creating strong anchor points within the repair zone for each anode. As indicated in Figure 3, anodes were placed at 12 to 24 in along the perimeter of the repair areas.

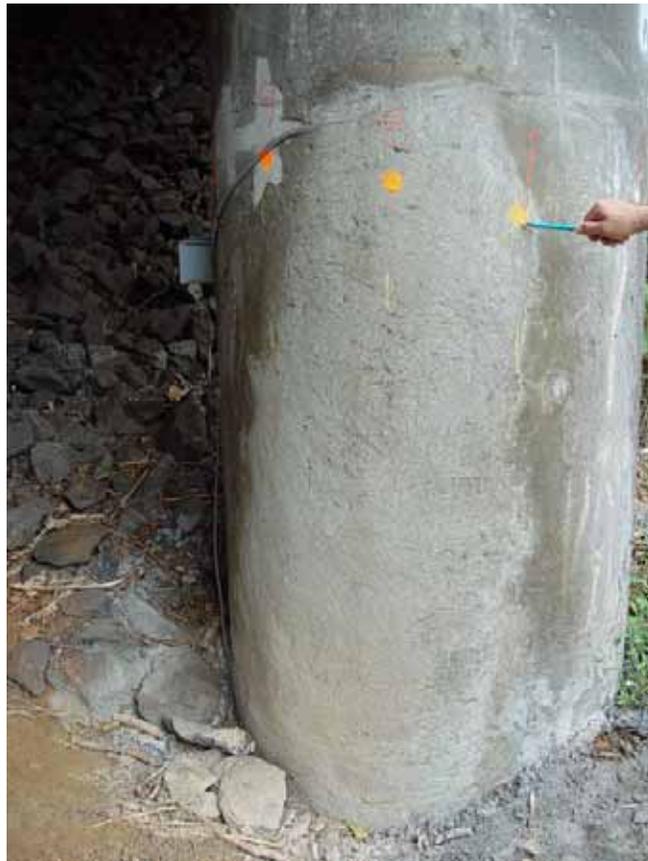
Figure 4. Electrical Potential and Resistivity Test Locations After Repair

A series of tests was conducted at and near repair locations to characterize the base concrete, repair materials, and track the performance of the anodes. To ensure the same locations were tested each time, orange paint marks were made on the column. The measurement points included regions containing the original concrete and locations where repairs were made using the shotcrete, which can be seen in Figure 4. For each column, electrical potential and resistivity were measured at 10 equal horizontal intervals around the perimeter of each column at a single elevation; they reflected readings within and adjacent to shotcrete patches. Illustrations of the test locations relative to the repairs are shown in Figure 5.

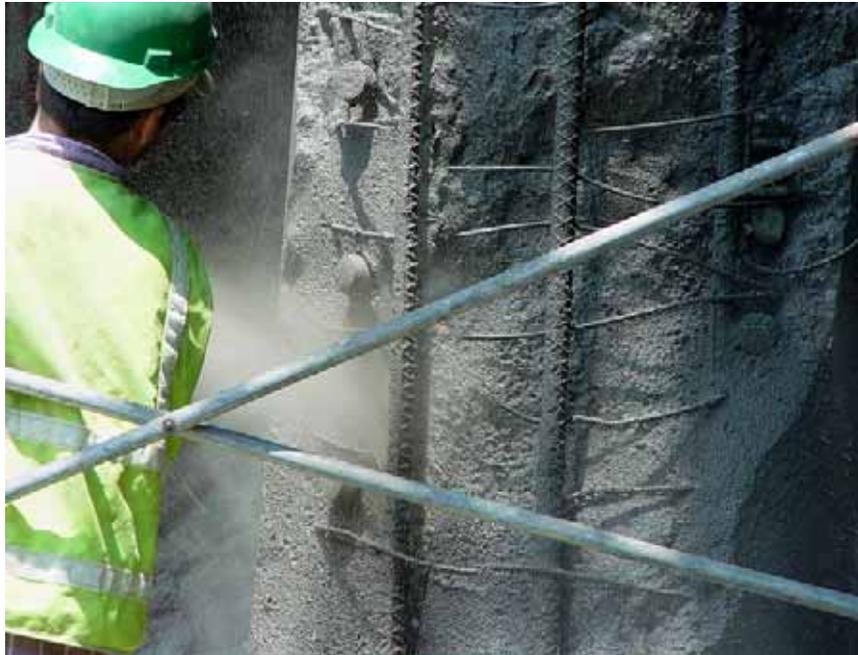
Figure 9. Placement of Shotcrete in Column Repair Containing Galvanic Anodes

After the repair areas were prepared, using the wires extending from the anodes, the anodes were placed with relative ease. The placement of each anode required less than 2 min each. Continuity checks indicated that the anode to steel circuit was complete and the repair region was ready for the shotcrete to be applied. As the shotcrete was applied, some of the anode pucks were observed to vacillate slightly, but each anode remained where it had been placed originally. The placement of the shotcrete repairs was monitored, as shown in Figure 9, with no noted complications.

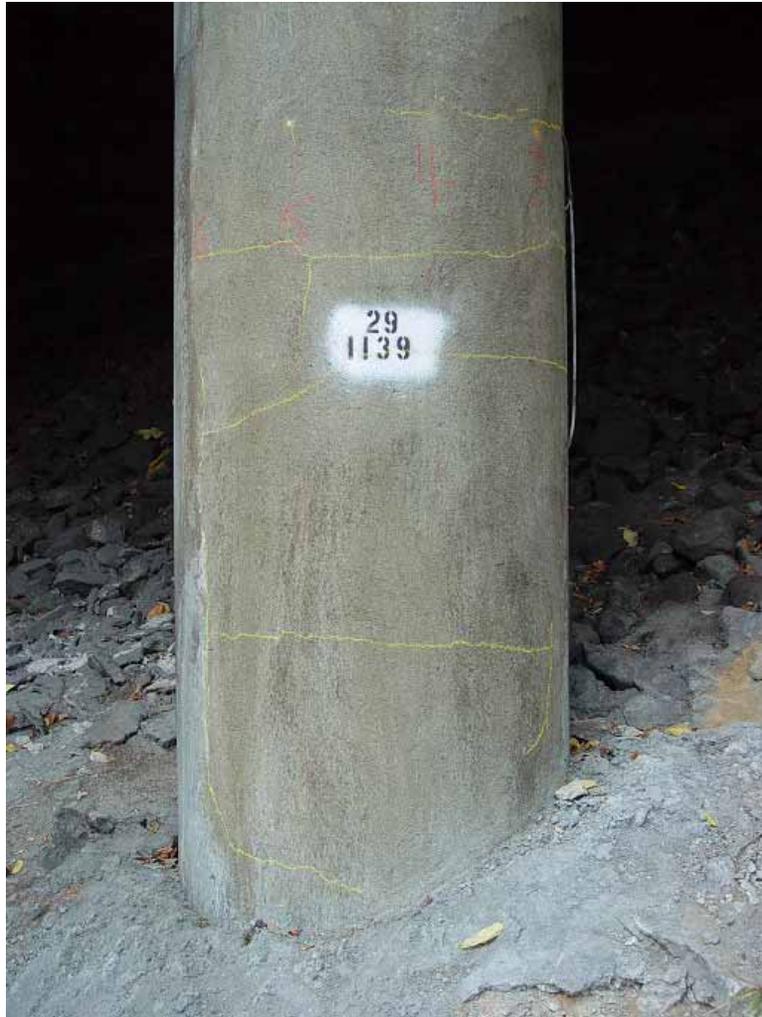
Figure 10. Pattern of Small-width Cracks in a Shotcrete Column Repair

A few days after shotcrete repairs were complete, electrical tests were conducted to monitor the performance of the anodes within the repair. The repairs were also visually assessed to determine any unusual activity. During the observations, the shotcrete within the largest of the repair areas, at column P12, exhibited fine cracks at regular intervals, transverse to the length

of the column, with a few vertical cracks connecting between them. Figure 10 is a photograph of the column showing the cracks highlighted with lumber crayon. The pattern of the cracking relative to the dimensions of the repair suggests that the cracks were likely due to drying shrinkage of the repair material during curing. The width of all cracks was less than 0.01 in .
