Galvanic Cathodic Protection of Corroded Reinforced Concrete Structures

David Whitmore, P.Eng., FACI, FICRI, FCSCE, NACE CP4 Vector Corrosion Technologies Ltd. 474 Dovercourt Drive Winnipeg, MB Canada R3Y 1G4 DavidW@Vector-Corrosion.com

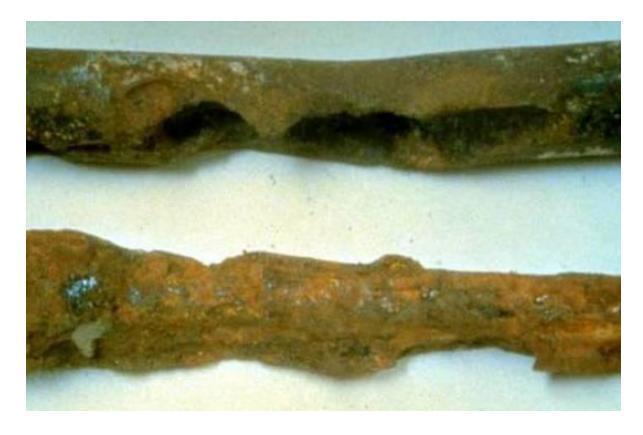
Figure 1: Chloride-induced Pitting Corrosion on Concrete Reinforcement

Chloride induced corrosion of reinforcing steel in concrete is a major problem worldwide. Chlorides can be introduced into the concrete via de-icing chemicals, seawater, or in certain cases as contaminants or additives in the initial concrete mix. This leads to localized breakdown of the normally passive steel reinforcement in the form of pitting corrosion (Figure 1).

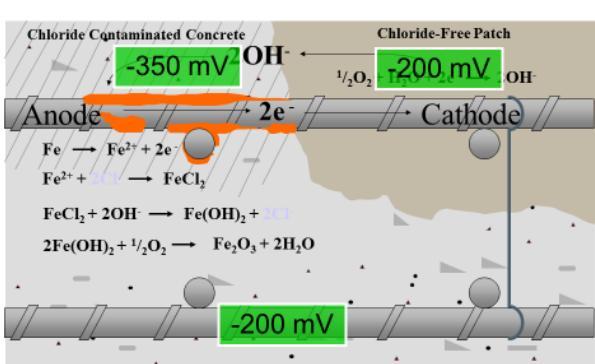
Incipient anodes or "Halo Effect"

Figure 2[A]: Illustration of Corrosion around Concrete Patch Repair

Corrosion leads to concrete deterioration and local patch repairs are often performed to address this concrete damage. Patch repairs are completed by removing the cracked or spalled concrete, cleaning the steel locally and filling the cavity with fresh repair mortar or concrete (Figure 2[A]). Unless all chloride-contaminated concrete around the patch is removed, however, the repair process can lead to the formation of incipient anodes (Figure 2[A]), new corrosion sites just outside the repaired area driven by the difference in potential between the steel in the chloride contaminated and chloride-free sections [1,2].

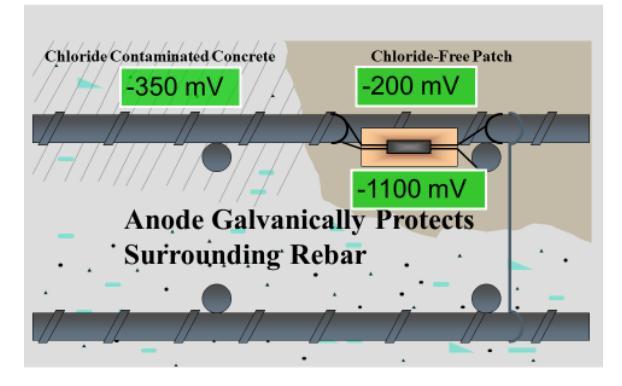
Installed Galvanic Anode

Figure 2[B]: – Illustration of Localized Galvanic Protection Protecting the Remaining Concrete Adjacent to Concrete Repair

This 'localized' problem has been eradicated by placement of discrete galvanic anodes around the perimeter of patch repairs (Figure 2[B]) which control incipient anode formation and avoid corrosion initiation [3,4]. One of the oldest monitored projects where such anodes were used has been monitored for over 16 years and is showing no signs of failure. The anodes are continuing to produce sufficient galvanic current to avoid corrosion initiation in the vicinity of the repairs, a phenomenon termed cathodic or corrosion prevention [5,6].

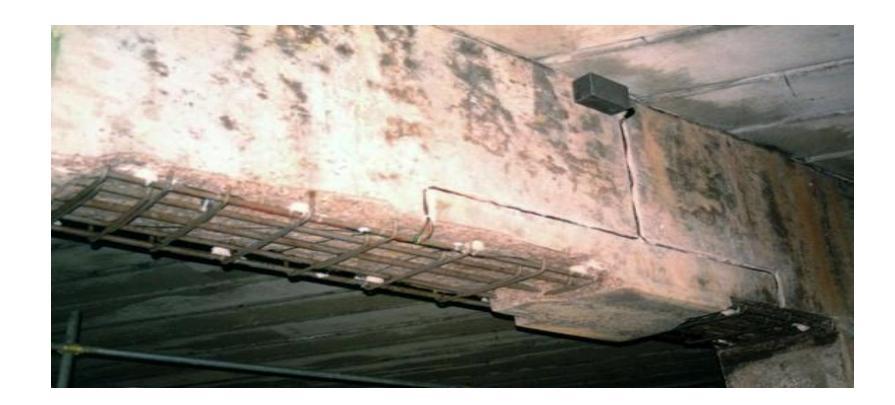
Figure 3: Embedded Galvanic Anode Installation on a Bridge Pier Cap

Specially designed galvanic anodes were first installed in the late 1990's to provide cathodic prevention (corrosion prevention) in concrete patch repairs. One of the first monitored installations was on a pier cap of a bridge in the UK (Figure 3).

A total of 12 anodes were installed at approximately 600mm centres along the perimeter of the repairs. The pier cap suffered from corrosion due to chloride contamination of up to 2% CI⁻ by weight of cement at the depth of the steel. The galvanic anodes were connected to the steel via a junction box allowing monitoring of the current. Figure 4 summarises the mean current density delivered by the anodes to the steel. The range is comfortably within the 0.2-2.0 mA/m² current density suggested for cathodic prevention over the entire 15-year period (Figure 4). More importantly, there is no evidence of corrosion initiation either within or around the periphery of the patch repair. Removal and examination of two anodes showed that over half the zinc mass was still available for continued protection such that the service life of the anodes is likely to be 25 to 35 years.

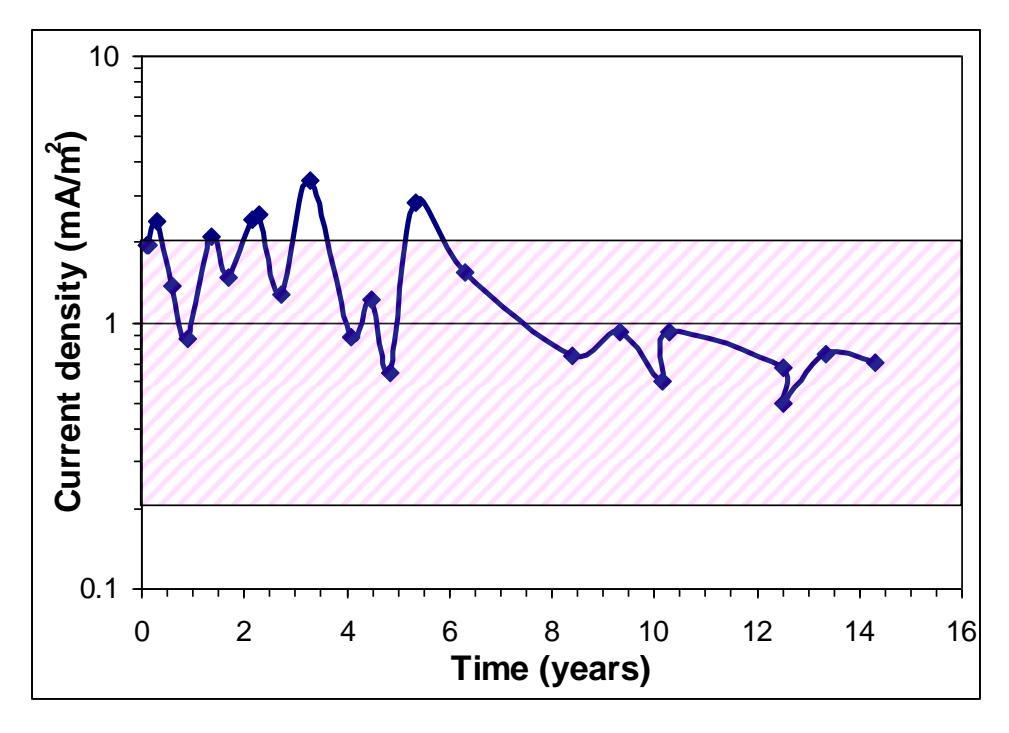
Figure 4: Current density to the reinforcing steel (mA/m²) plotted vs time. Shaded area indicates current density for cathodic prevention (corrosion prevention) as per EN12696 (0.2 to 2.0 mA/m²)

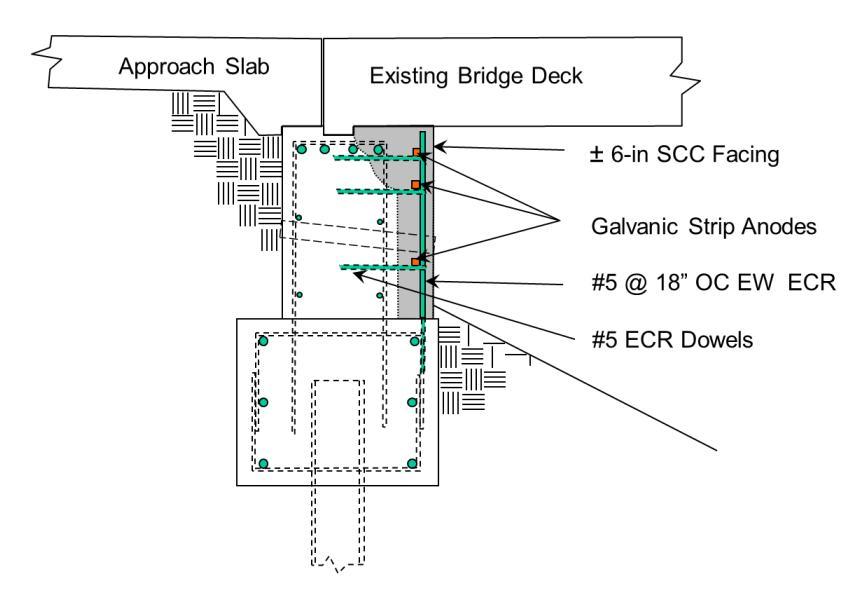
Figure 5: Galvanic Encasement of Abutment

This bridge was repaired in July, 2005 with a galvanic encasement. The ODOT bridge substructure repair included re-facing the abutments of multiple bridges with distributed embedded galvanic anodes designed to provide cathodic protection (Figures 5 & 6[A]) for the steel in the entire abutment. The bridge has been monitored as part of an ODOT technology evaluation program since May, 2005. (Figure 6[B]).

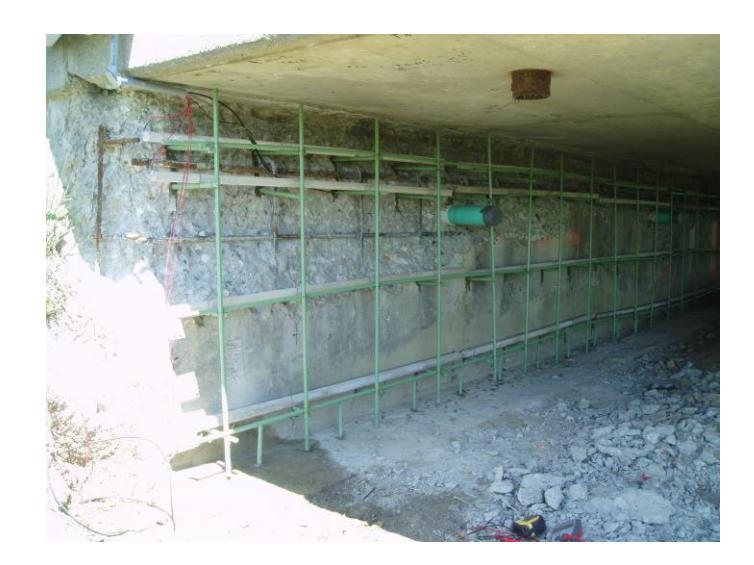
Figure 6[A] –Galvanic Distributed Anodes Installed Across Face of Abutment

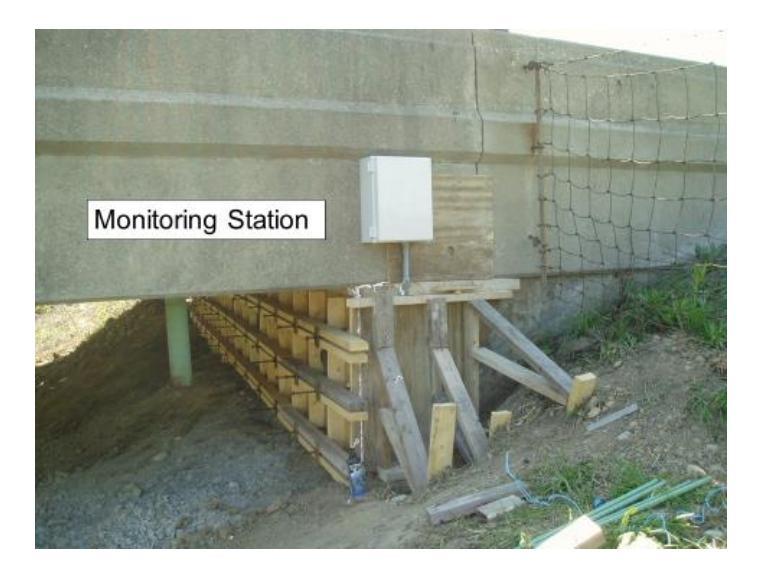
Figure 6[B]: Distributed Anode System Monitoring Cabinet

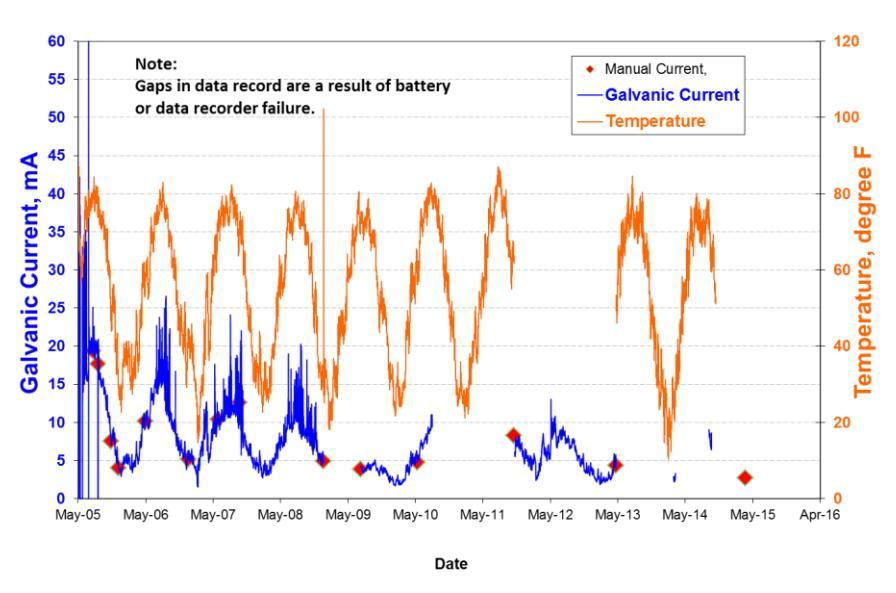
Figure 7: Ohio DOT Galvanic Current and Temperature History

The monitoring program included the installation of dataloggers to monitor the current flowing from the galvanic anodes to the reinforcing steel as well as the temperature of the concrete itself (Figure 7). In addition to the dataloggers, current, potentials and polarization was measured manually when personnel visited the project site (Figure 8).

Galvanic current data collected at regular intervals can be integrated to precisely calculate the consumption of the galvanic anodes. The calculated anode life is approximately 35 years. This calculation includes an anode utilization factor of 0.8 and an anode efficiency factor of 0.9.

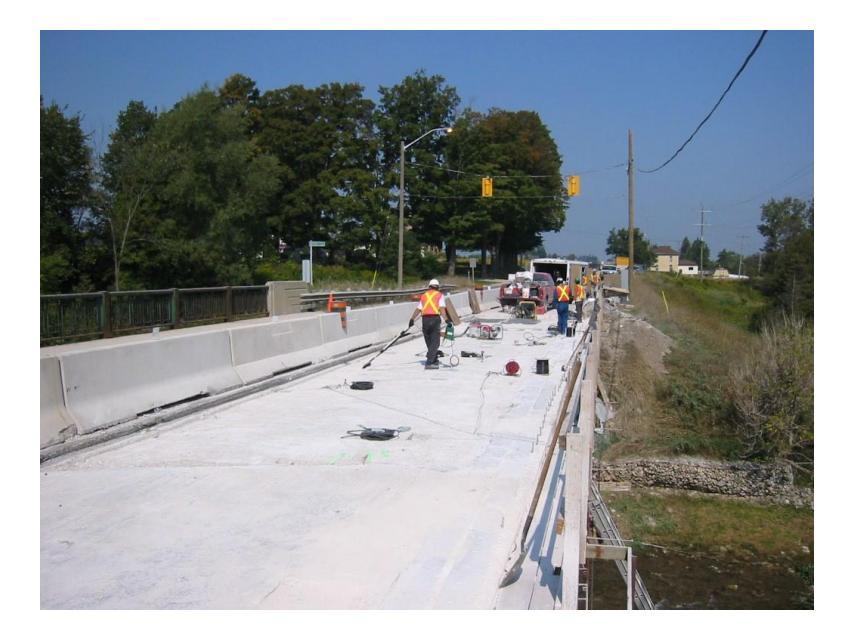
Figure 9: Bridge Deck after Milling

The bridge deck was prepared by milling off a portion of the existing concrete cover. As a result the majority of the existing reinforcing steel was to remain in chloride containinated concrete. A 'distributed' galvanic cathodic protection system consisting of elongated galvanic anodes placed in rows and connected to the existing reinforcing steel was installed. The galvanic anodes consisted of a zinc core encased in a low resistivity alkaliactivated mortar shell and were prefabricated to fit the dimensions of the deck. (Figure 10)

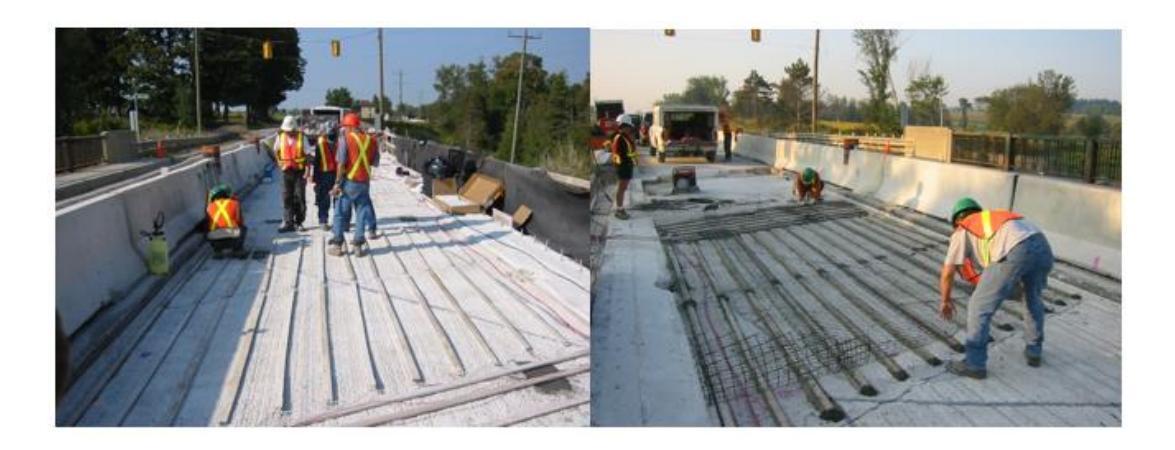
Figure 10: Installation of Distributed Galvanic Anodes and Carbon Fiber Grid prior to Concrete Overlay

A carbon fiber grid was installed to reduce shrinkage and minimize cracking of the 2.5 inch (60 mm) thick silica fume deck overlay (Figure 10).

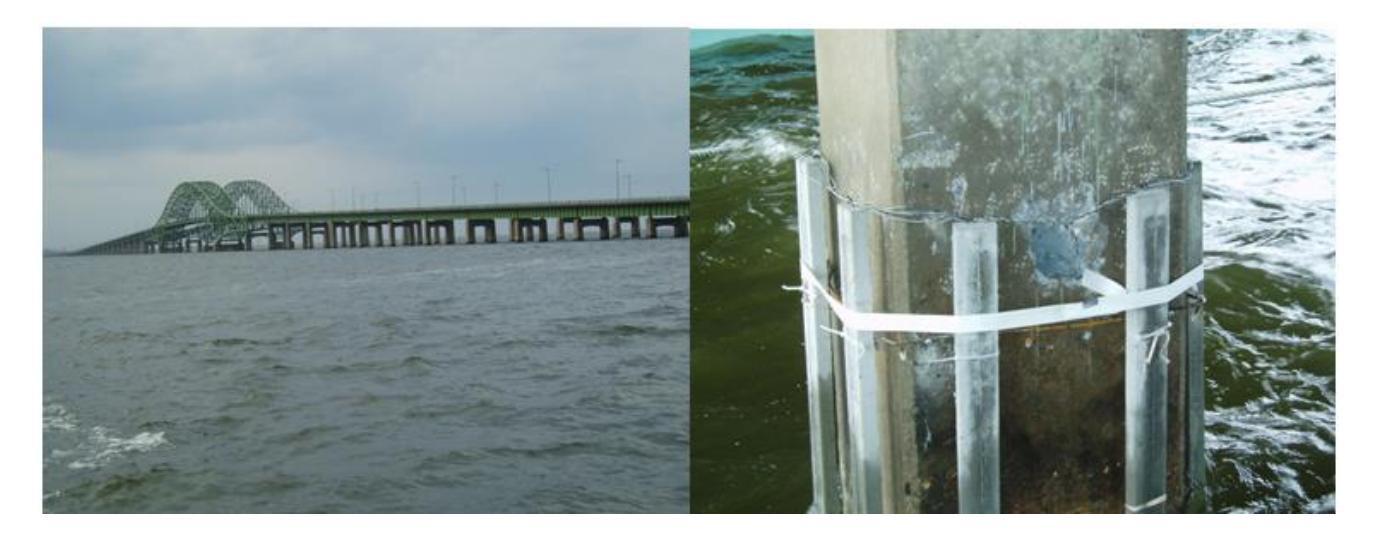
Figure 12[A]: Alkali-activated Distributed Galvanic Anodes for Pile Protection on the Robert Moses Causeway

In 2006, New York State DOT completed a project on the Robert Moses Causeway to Long Island, NY (Figure 12[A]). The project included installation of galvanic cathodic protection jackets to protect the tidal and splash zone of 764 columns (Figure 12[B]).

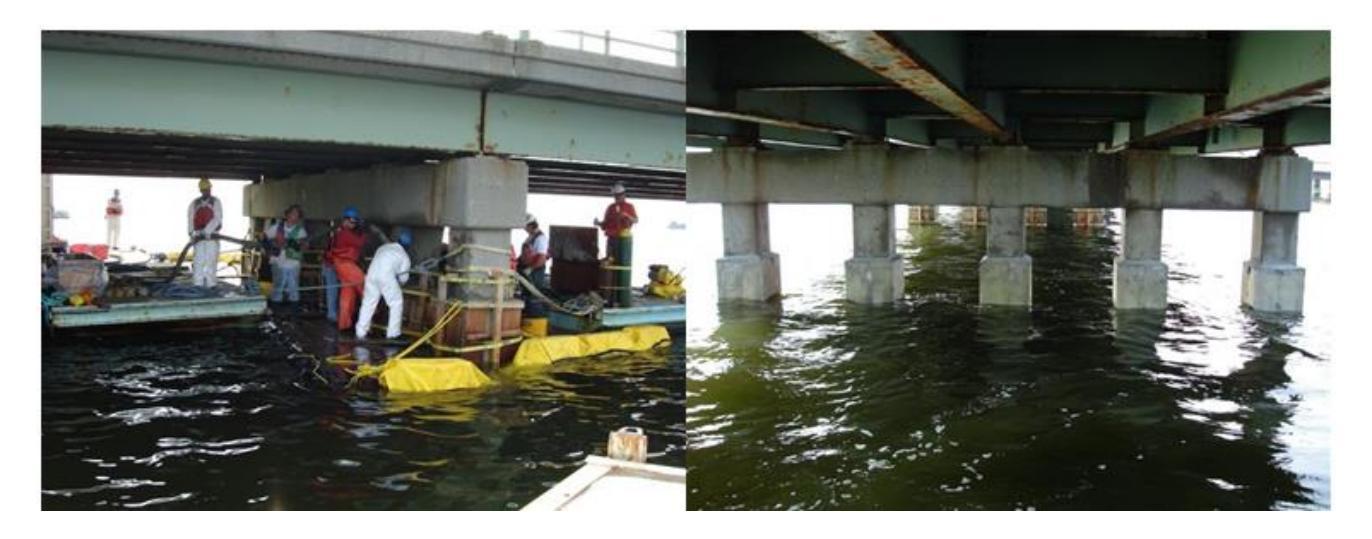
Figure 12: FRP Concrete Placement and Jacket Elevation at High Tide

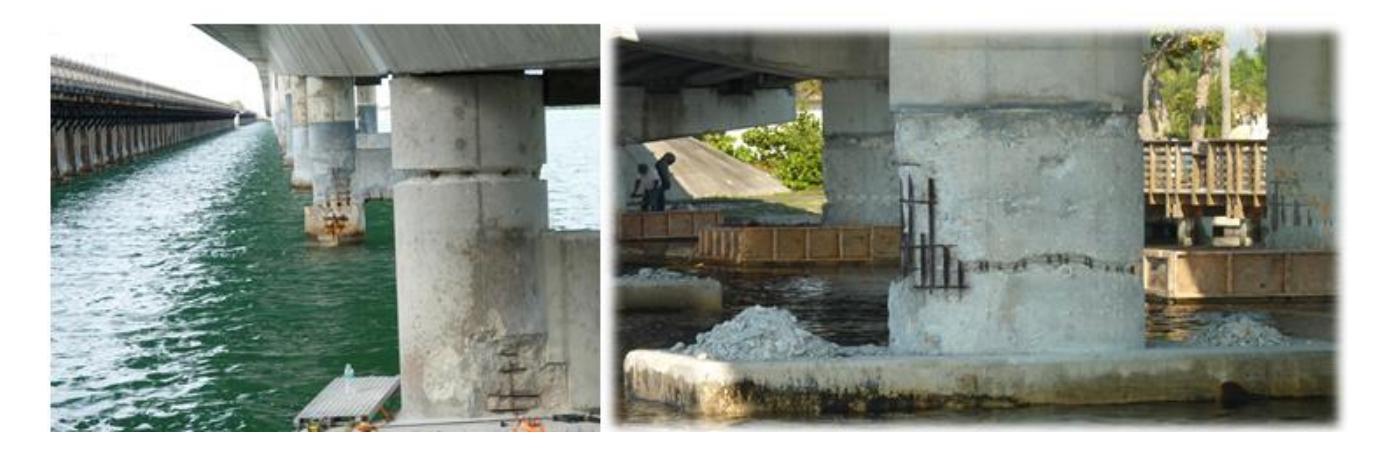
Figure 13: Deteriorated Columns and Removal of Damaged Concrete

These Florida DOT marine bridges located in south Florida and the Florida Keys were suffering from corrosion due to chloride contamination from storm surges and atmospheric exposure (Figure 13).

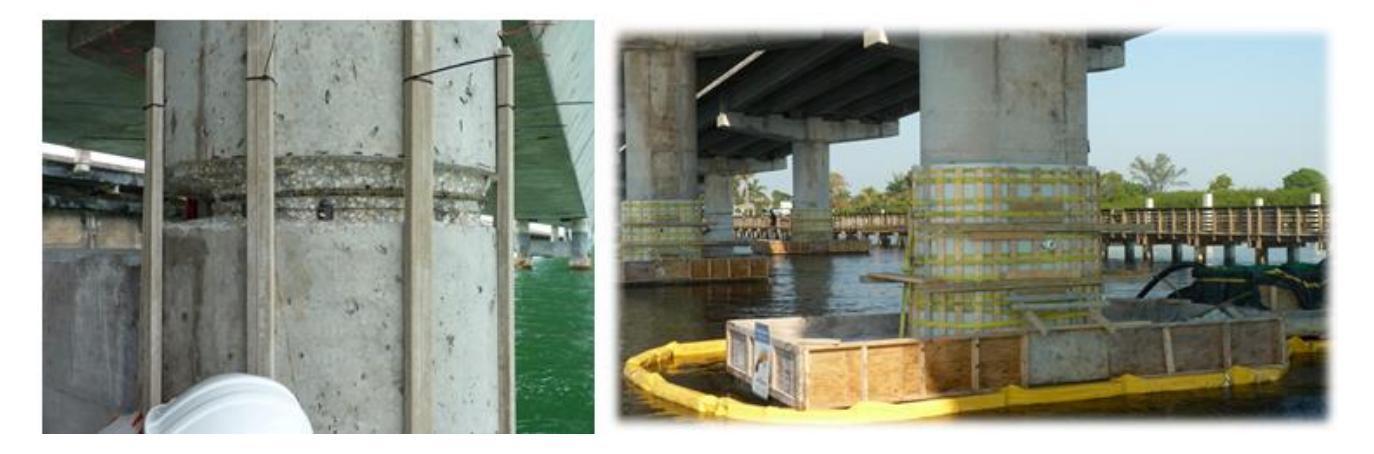
Figure 14: Installation of Alkali-Activated Galvanic Anodes and Jacket

Florida DOT has utilized other corrosion protection options such as arc-sprayed zinc and zinc mesh jackets on this type of structure in the past with limited success. These projects utilized distributed alkali activated galvanic anodes installed inside stay-in-place forms (Figure 14).

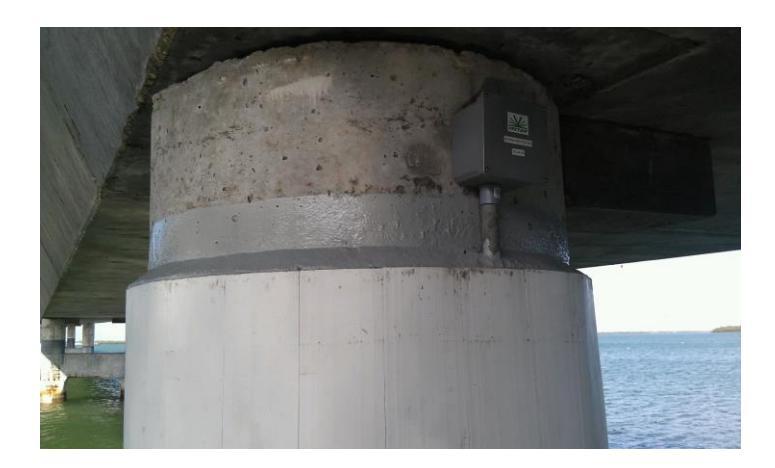
Figure 15: Installed PVC Galvanic Cathodic Protection Jacket with Monitoring Station

The stay-in-place form can be fiberglass or PVC with PVC having the advantage of being modular and providing greatly improved durability and bonding with the concrete column.

As with all FDOT projects, monitoring provisions were provided when the column jackets were installed such that the long-term performance and effectiveness in providing cathodic protection could be verified (Figure 15).

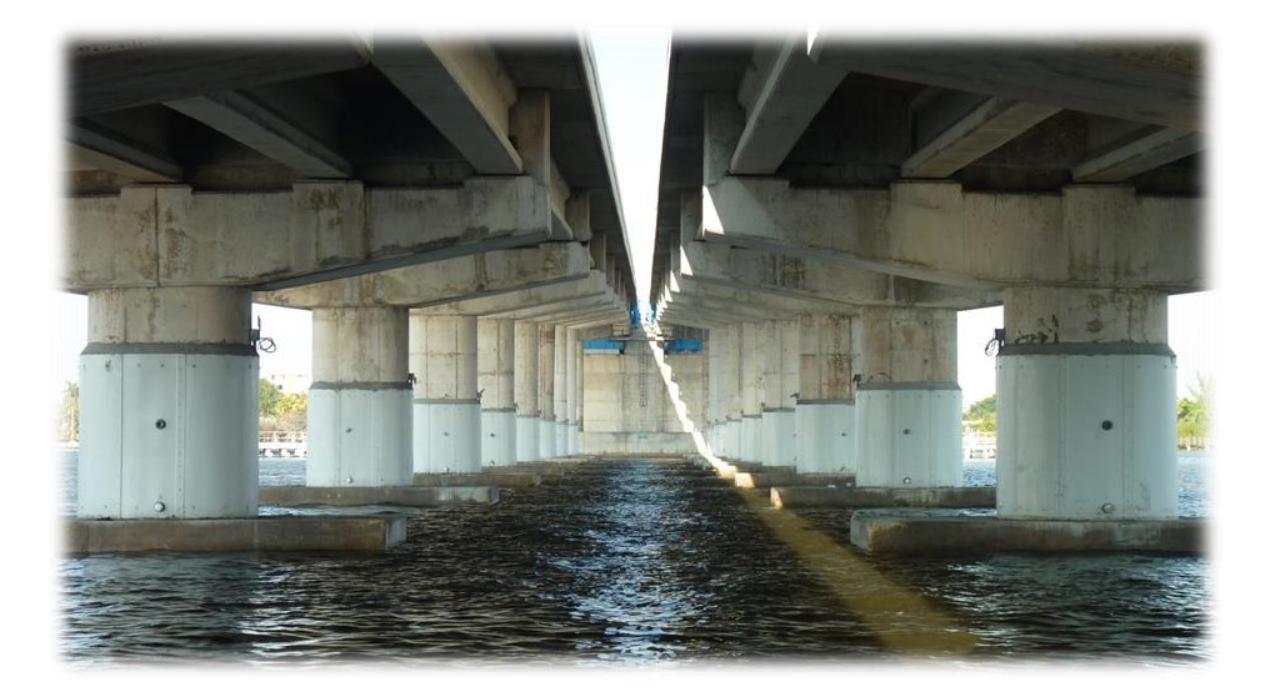
Figure 16: Installed Above-Water Alkali-Activated Galvanic Cathodic Protection Jackets

FDOT has used zinc mesh galvanic jackets to protect reinforcing steel in the splash zone. Research has shown these jackets to be effective if they are kept wet but the zinc mesh will become more passive and generate less protective current for each foot of elevation above the high tide line. Since these columns are fully above the high tide line activated zinc anodes were specified and installed (Figure 16).
